Simplifying Immediate Implant Placement and Restoration in the Maxillary Anterior

The case illustrated in this article highlights a simplified approach to immediate implant placement and its restoration for a failing maxillary single anterior tooth.

By Rami Salloum, DDS, Gregori M. Kurtzman, DDS

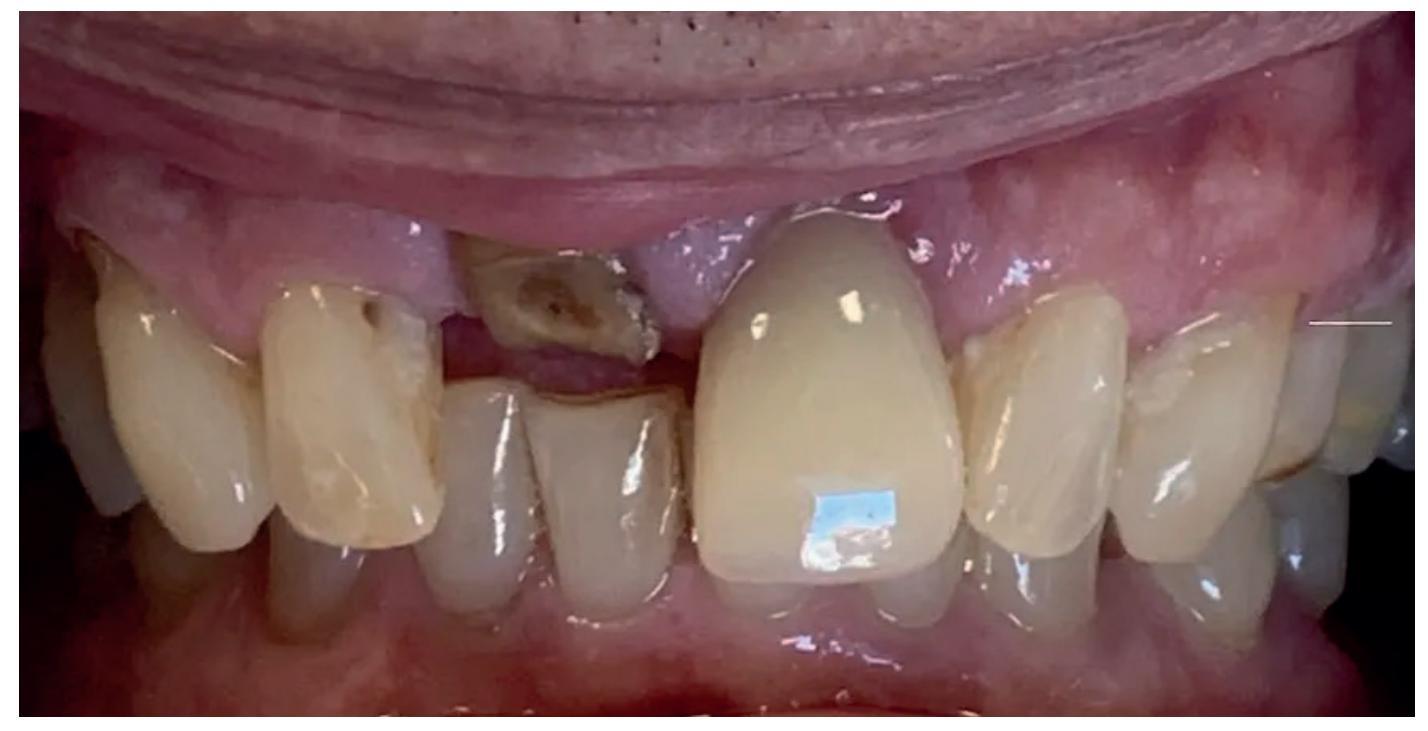
Fig 1. The patient presented with a fracture of the maxillary right central incisor (tooth No. 8) at the gingiva.

A 78-year-old male patient presented for consultation with a fractured maxillary right central incisor (tooth No. 8) **(Figure 1)**. He was currently using a temporary partial denture for the missing crown of the tooth. The patient expressed interest in replacing the tooth with an implant. A review of his medical history revealed no significant medical issues.

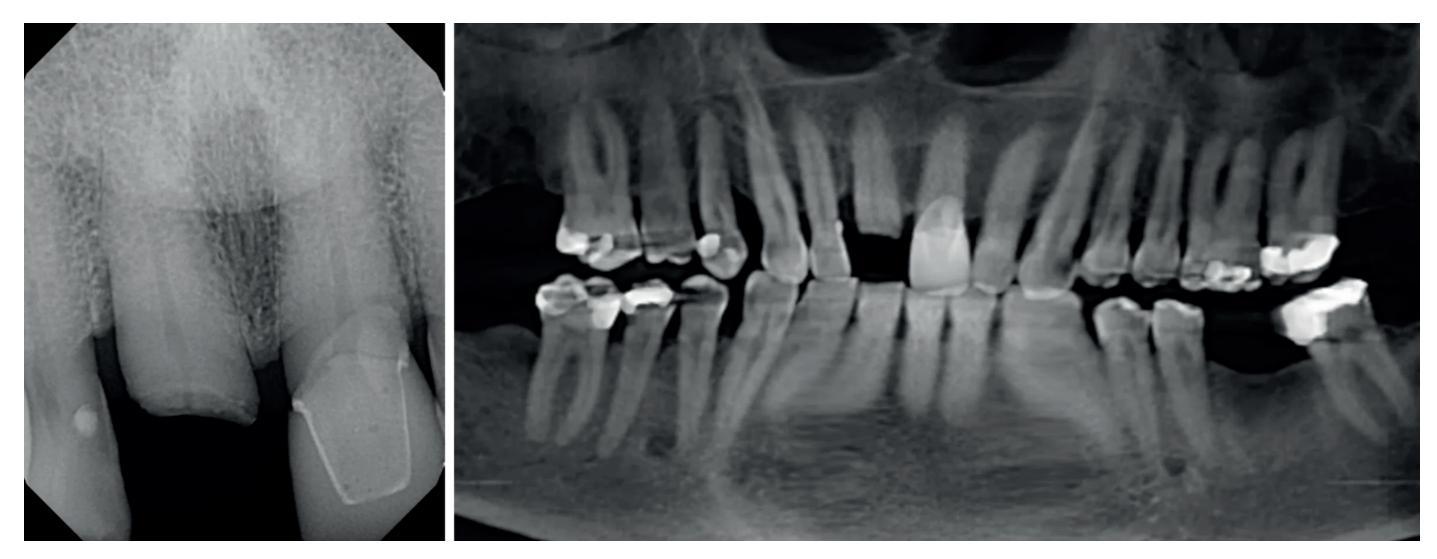
Fig 2. Periapical radiograph (left) and panoramic view from a CBCT scan (right) showing the fractured central incisor in relation to the surrounding anatomy.

A periapical radiograph of tooth No. 8 was taken to evaluate the remaining portion of the tooth at the gingiva and the adjacent anatomy (Figure 2, left); a cone-beam computed tomography (CBCT) panoramic radiograph was recorded (Figure 2, right) to assess the dentition. A periodontal examination was performed, and the rest of the dentition was found to be healthy with no issues noted. Tooth No. 8 had slight bone loss on the distal aspect, and no periapical pathology was noted radiographically. Sufficient anatomy was present apical to the root of tooth No. 8 and adjacent to it on the mesial and distal aspects to permit implant placement.

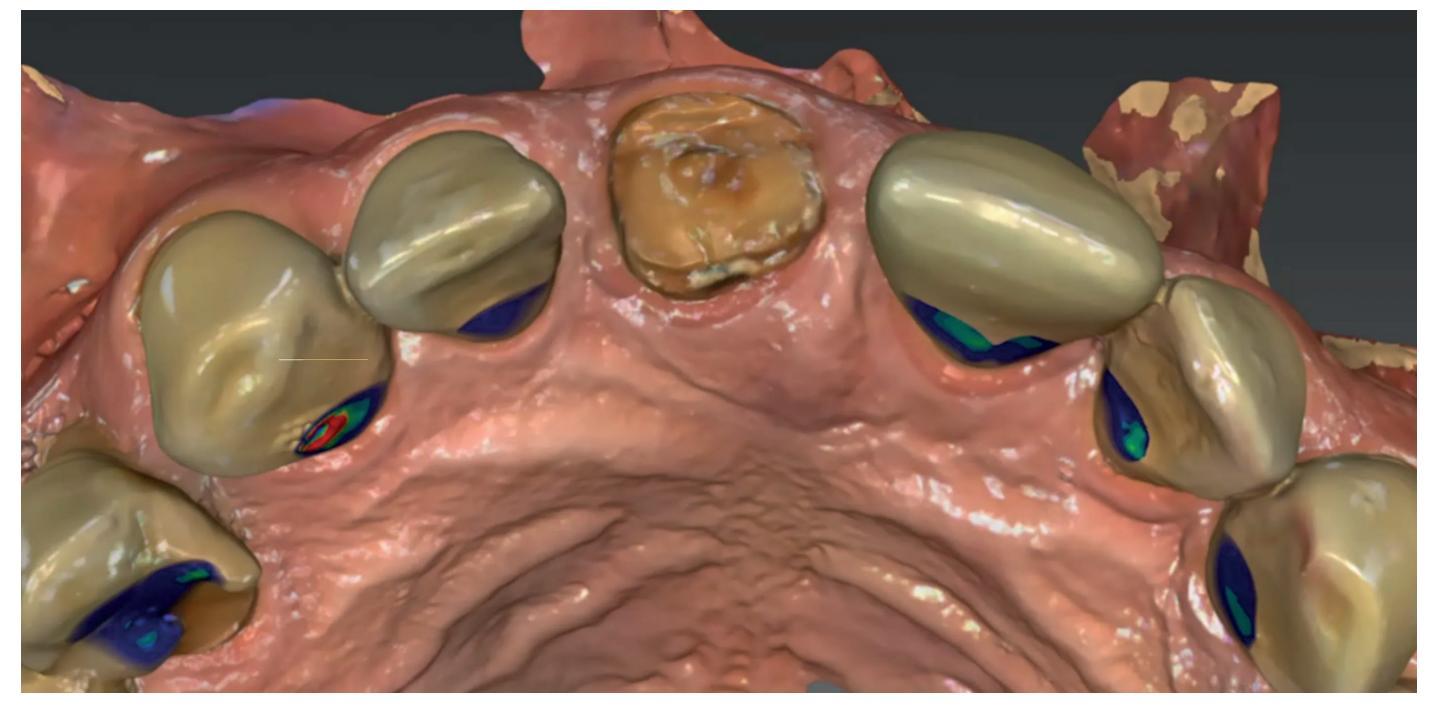
Fig 3. Virtual scan of the maxillary anterior region showing the fractured right central incisor (tooth No. 8).

A CBCT scan was performed, and both arches were intraorally scanned with an intraoral scanner (Primescan, Dentsply Sirona, dentsplysirona.com) for implant planning **(Figure 3)**. A full-arch impression was taken for fabrication of an Essix temporary retainer to be utilized during the healing phase of treatment after implant placement. The patient was then dismissed.

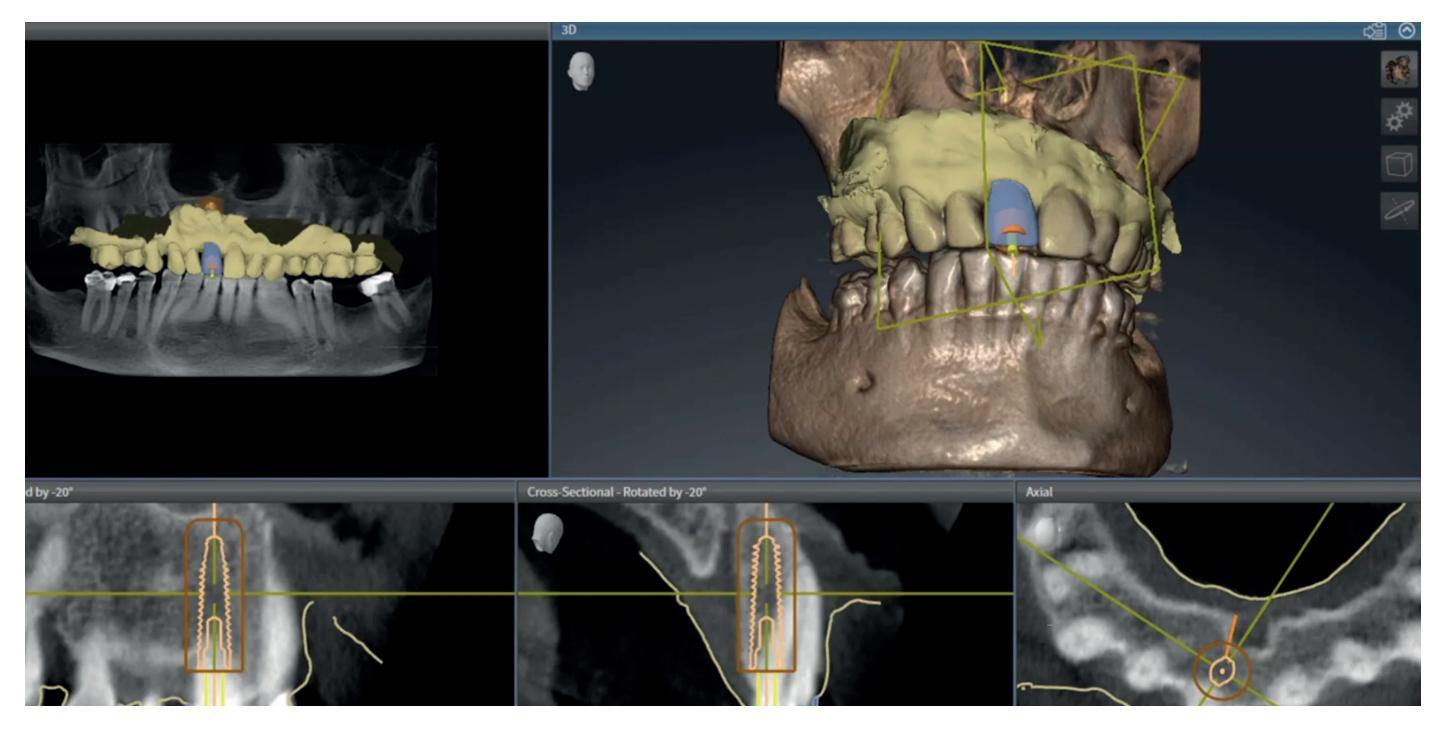
Fig 4. Virtual planning of the implant placement (bottom images) and design of the virtual restoration (top two images)

The CBCT and intraoral data was imported into inLab and SICAT softwares (Dentsply Sirona) to plan the implant placement. A virtual coronal portion of tooth No. 8 was placed onto the virtual arch in the software to facilitate implant placement based on the prosthetic positioning of the final restoration in coordination with the present anatomy (Figure 4). The implant position was then created virtually to accommodate a 4.2 mm x 13 mm implant (Spiral SB/LA Implant, Ritter Implants, ritterimplants.com). A surgical stent was created virtually in the software (Figure 5). The surgical guide was then milled with clear polymethyl methacrylate (PMMA) on an inLab MC X5 milling machine (Dentsply Sirona). The Essix temporary retainer was created using the model from the 3D-printed digital wax-up made at the prior appointment.

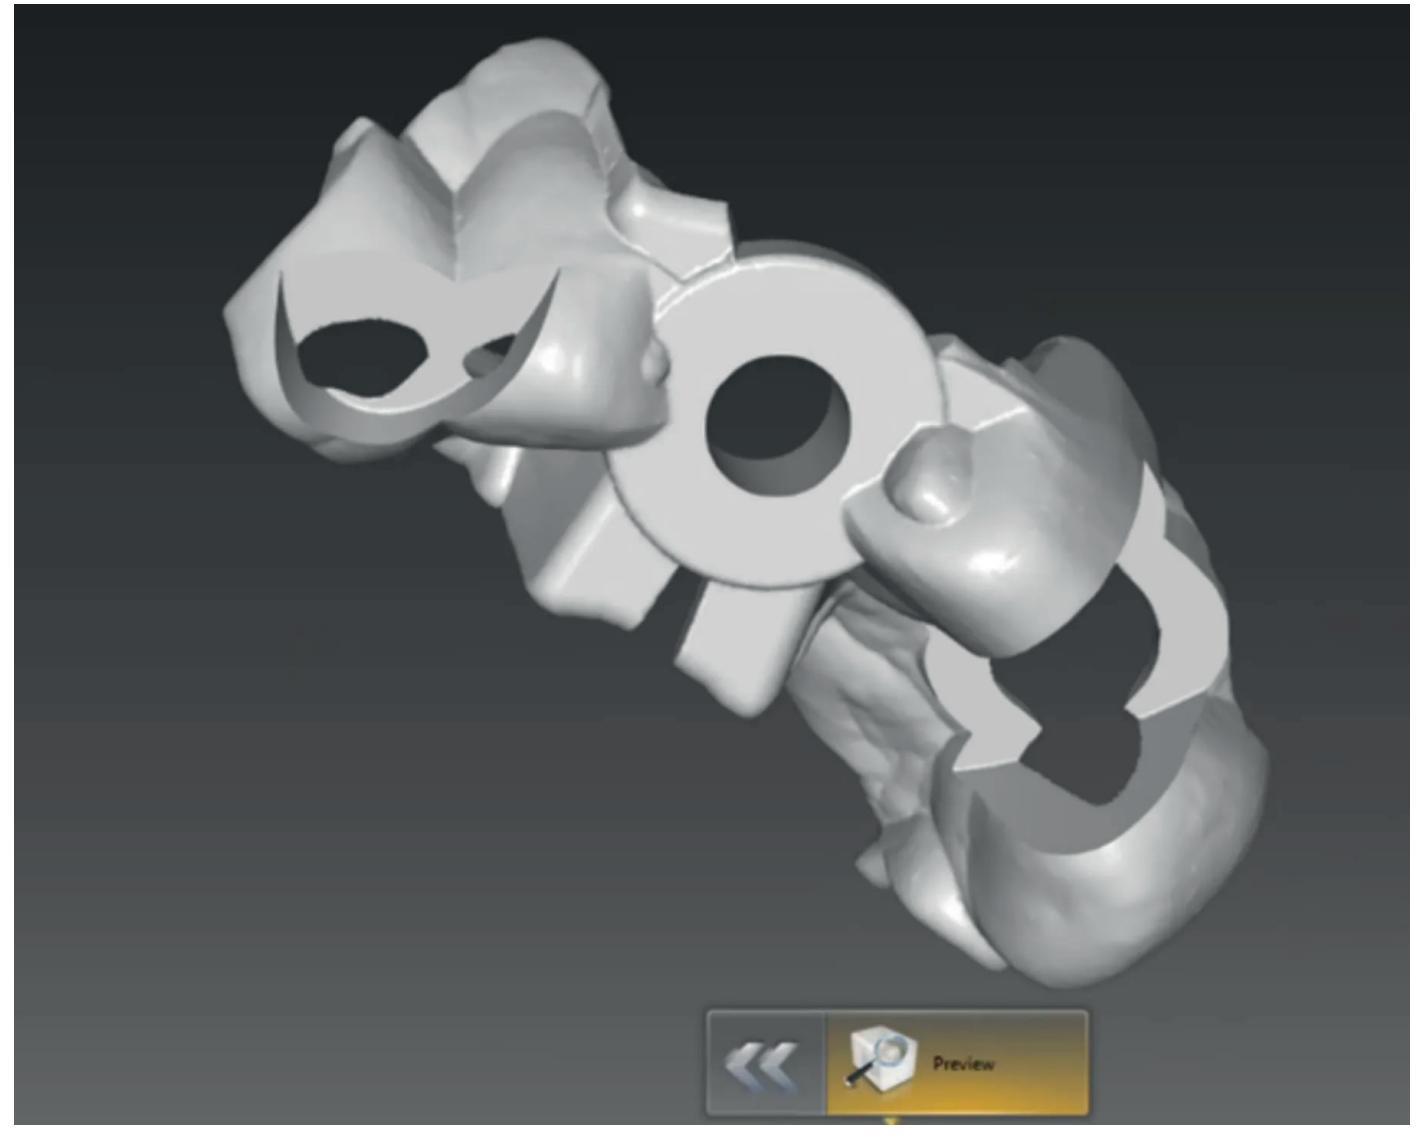
Fig 5. Virtual design of the surgical stent created in the software.

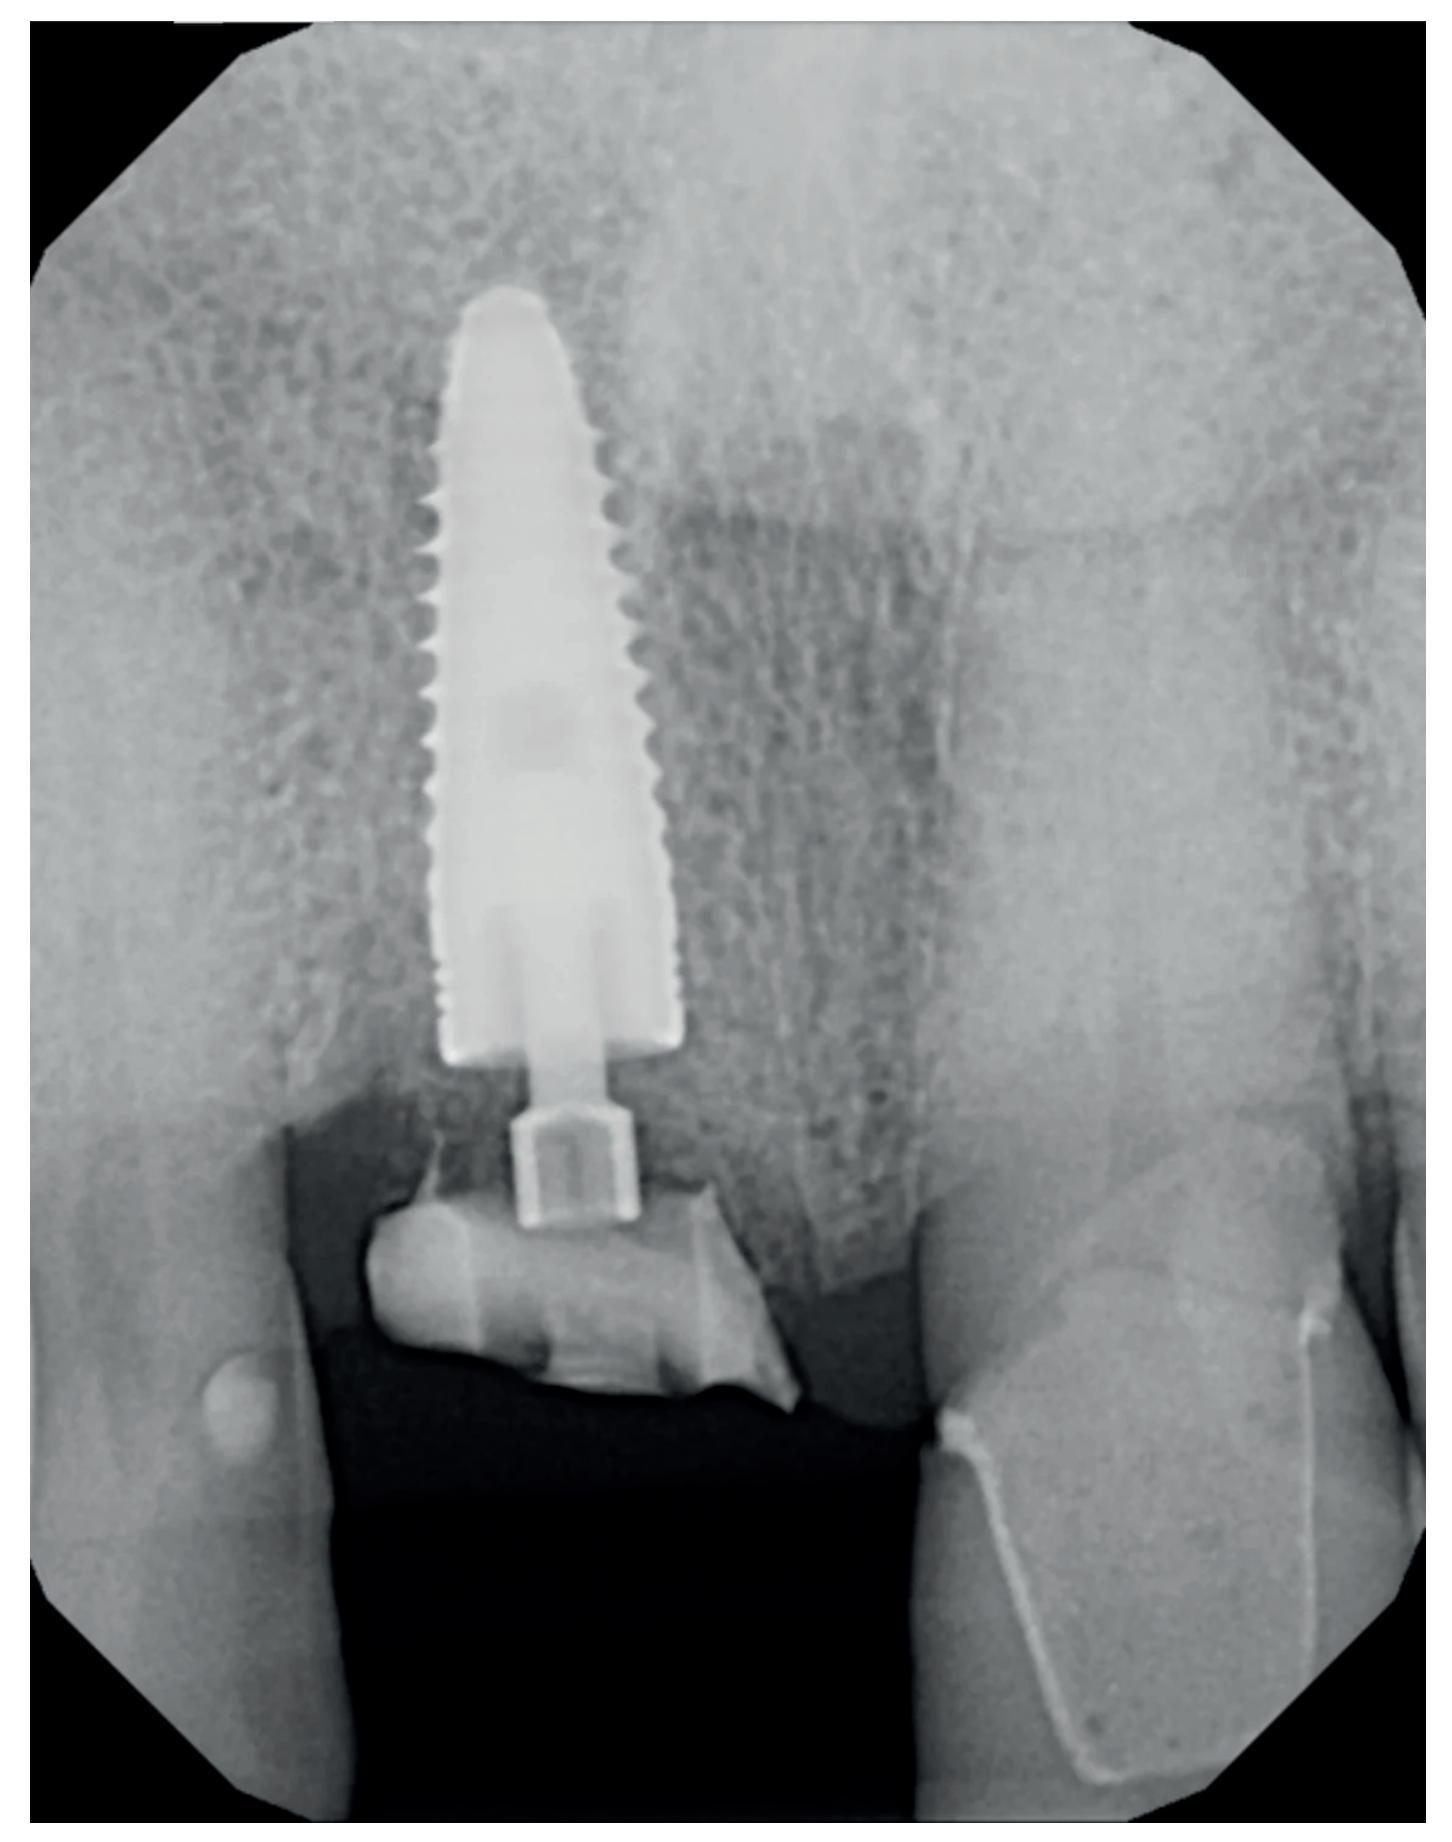
Fig 6. Periapical radiograph following the placement of a customized healing abutment after crestal graft placement documenting the implant position in relation to the surrounding anatomy and the crestal depth of the implant.

A periapical radiograph was taken to verify seating of the healing abutment and document the implant position relative to the anatomy **(Figure 6)**. Pressure was applied to the gingival tissue to aid in clot formation between the soft tissue and sticky bone. Sutures were placed to keep the soft tissue in contact with the custom healing abutment using 4-0 chromic gut sutures. An Essix provisional was inserted intraorally, and the patient was instructed to keep it in place 24 hours a day except only to remove it to perform oral hygiene until the next appointment in 2 weeks **(Figure 7)**.

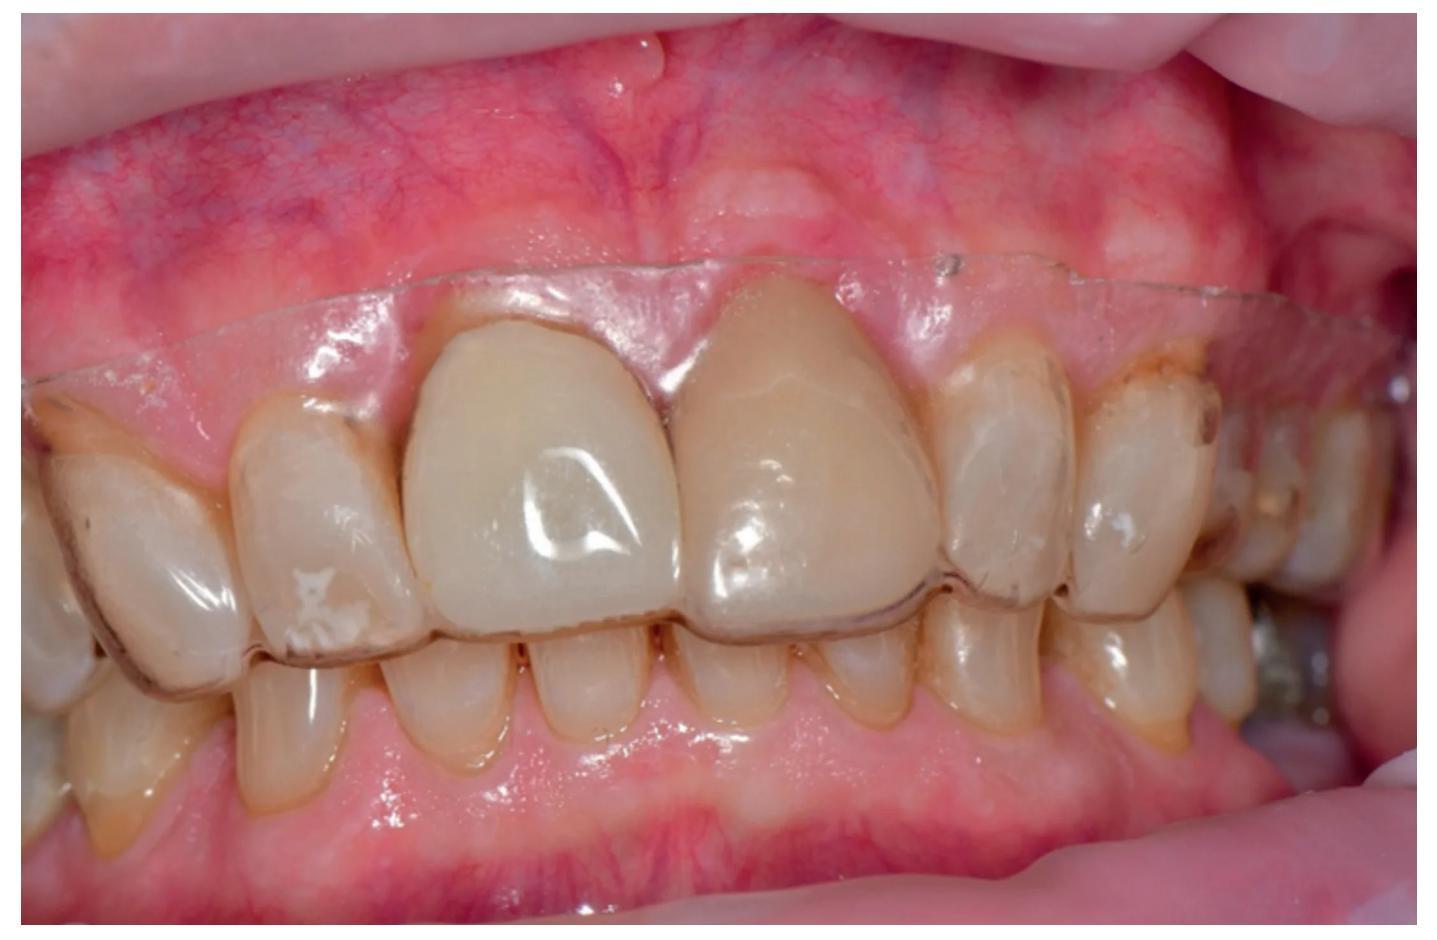
Fig 7. An Essix provisional was placed as a temporary restoration during the implant osseointegration phase of treatment.

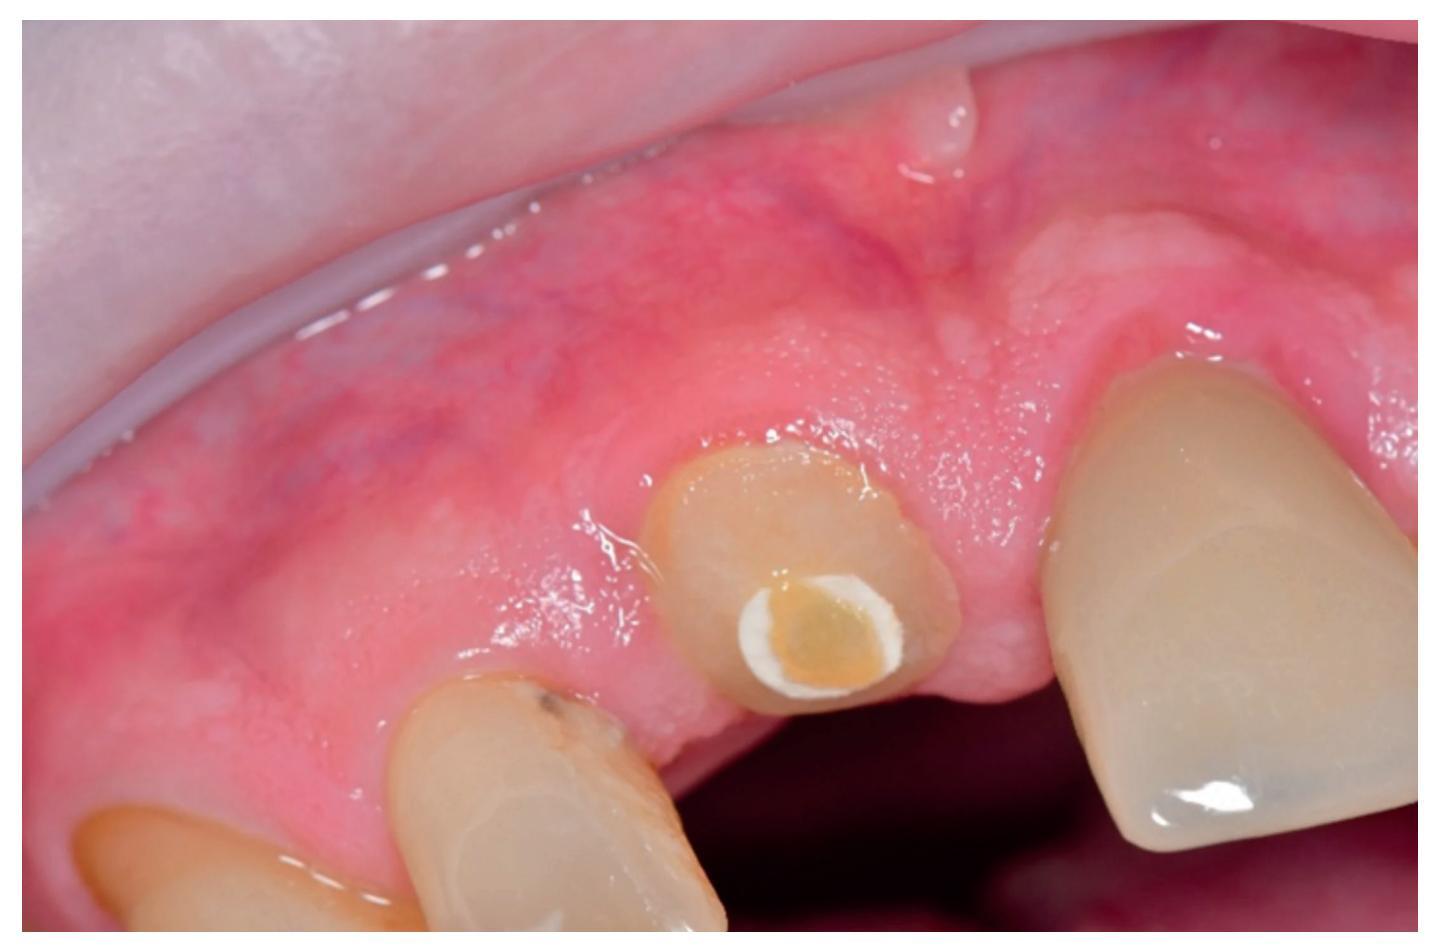
Fig 8. The customized healing abutment following completion of the implant integration phase of treatment.

At 4 months post-implant placement the patient presented to have the site healing checked and to assess implant osseointegration. Upon removal of the Essix provisional, the soft tissues presented without inflammation around the custom healing abutment (**Figure 8**). The healing abutment was removed, revealing a well-formed gingival cuff with no signs of inflammation (**Figure 9**). An implant stability quotient (ISQ) reading of 72 confirmed successful osseointegration of the implant, indicating that it was ready for restoration.

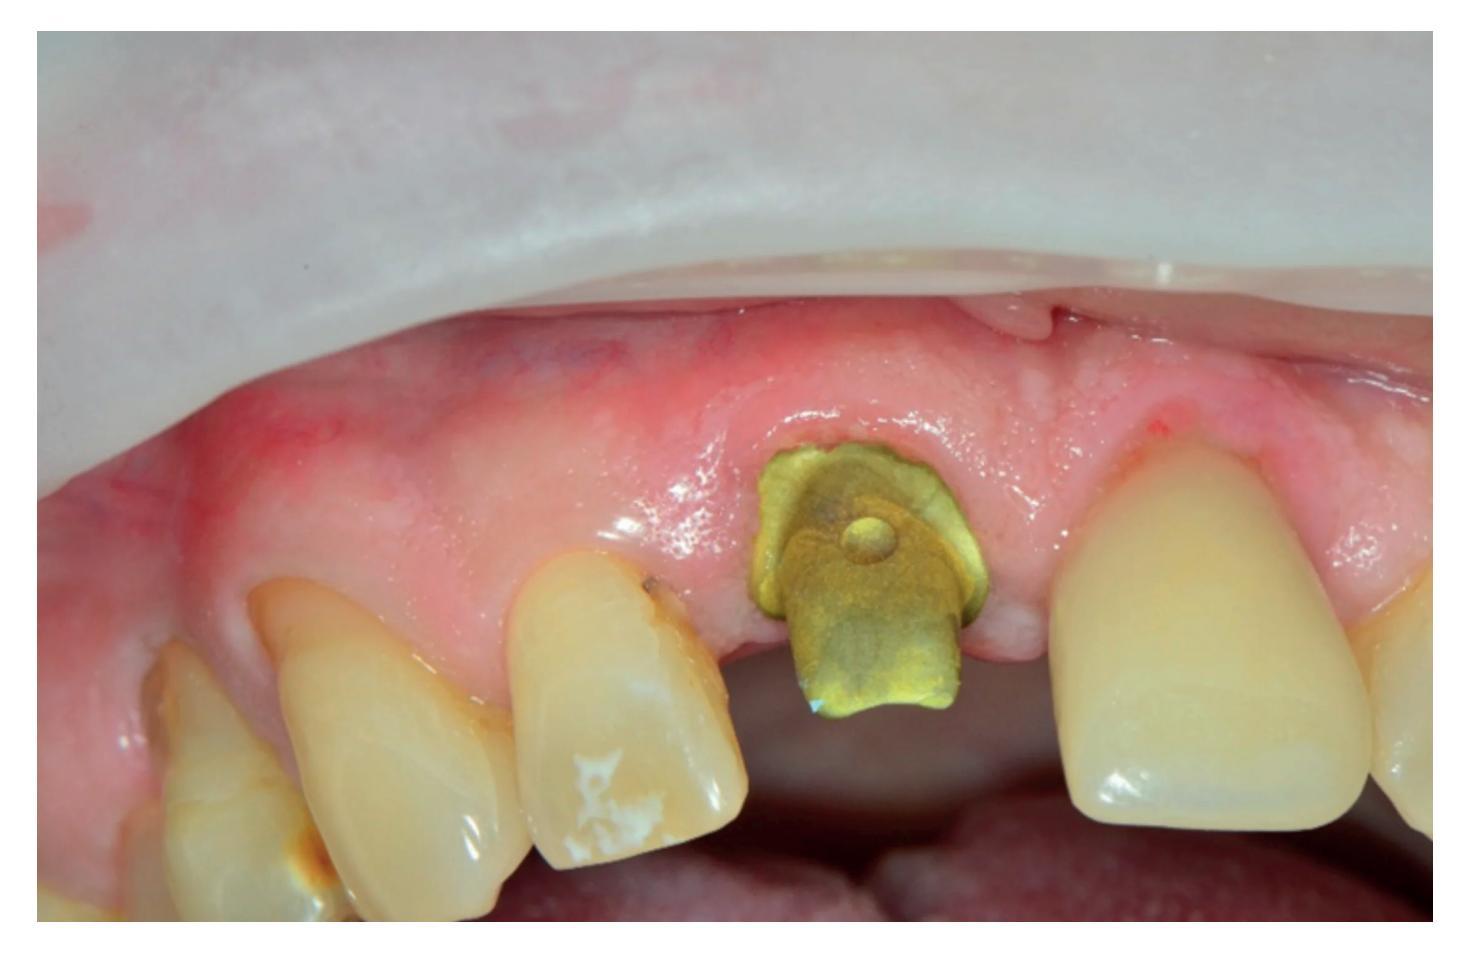
Fig 11. The custom abutment was placed and the screw hand-tightened.

The implant custom abutment and crown were returned from the laboratory and the patient presented for insertion. The healing abutment was removed, and the custom restorative abutment was inserted into the implant and the screw was hand-tightened (**Figure 11**). A periapical radiograph was taken to verify complete mating of the implant and abutment connector (**Figure 12**). The crown was tried in intraorally and marginal fit was verified. The patient was handed a mirror and approved the esthetics of the restoration.

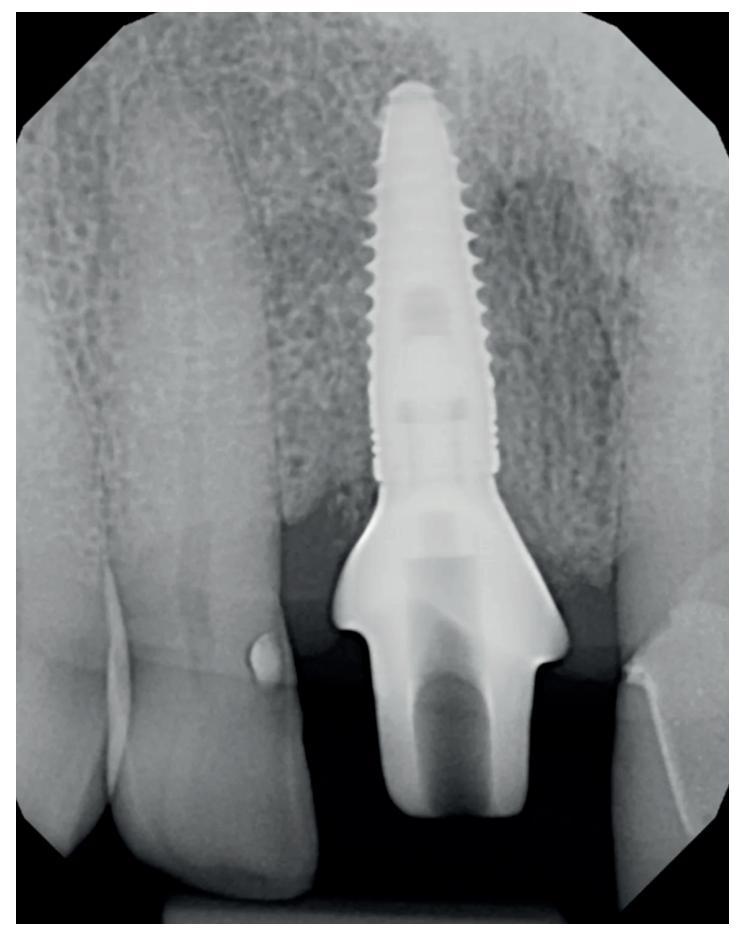
Fig 12. Periapical radiograph confirming proper seating of the abutment into the implant.

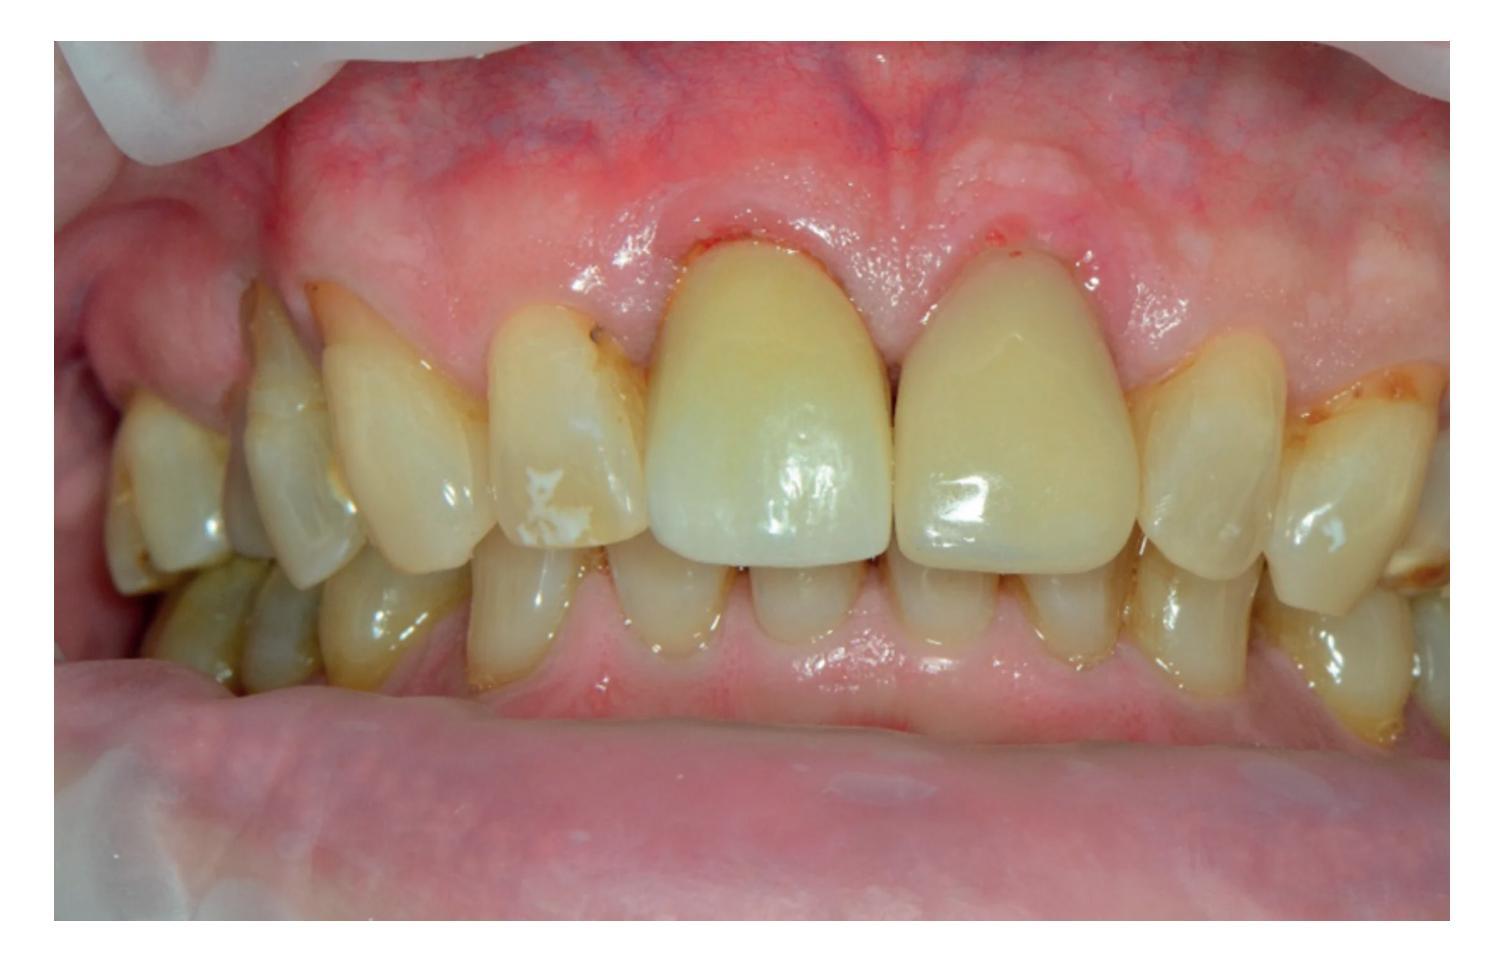
Fig 13. The final restoration was cemented on the custom abutment completing treatment at No. 8.

The crown was removed and the screw access on the abutment was sealed with Teflon tape. The crown was then cemented to the abutment using a glass-ionomer cement (GC FujiCEM[®] 2, GC America, gc.dental/america). Upon cement setting, any marginal cement was removed with an explorer. The occlusion was checked and adjusted as needed (Figure 13). A periapical radiograph was recorded to document the completed restoration (Figure 14), and an impression was taken with the intraoral scanner (Primescan) for production of a nightguard.

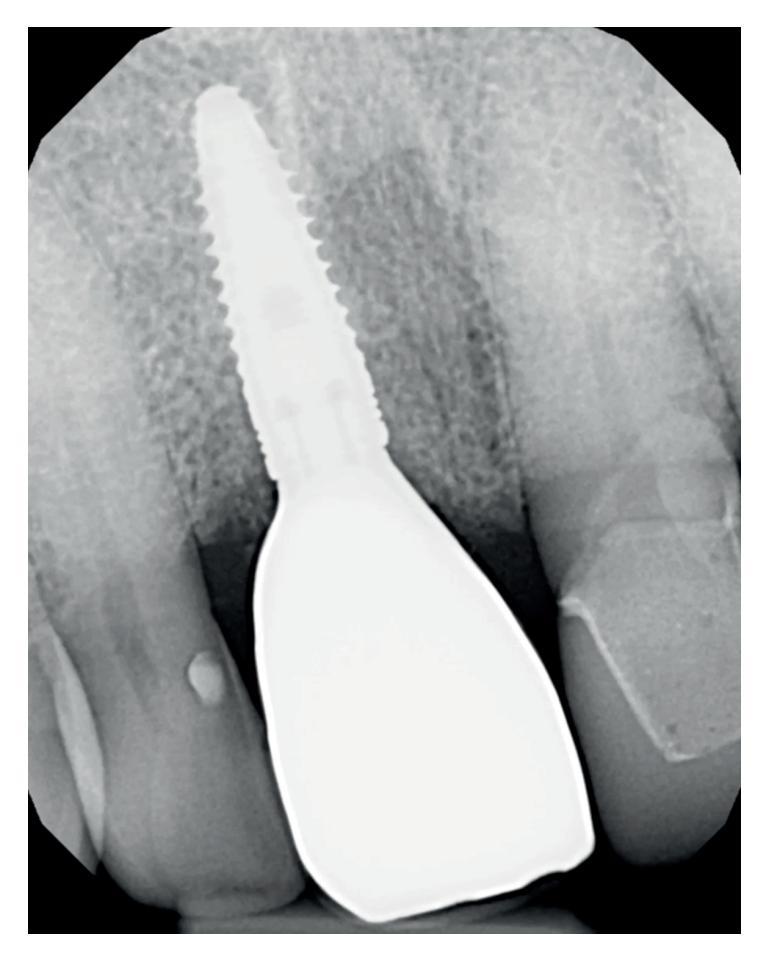
Fig 14. Periapical radiograph confirming proper seating of the abutment into the implant.

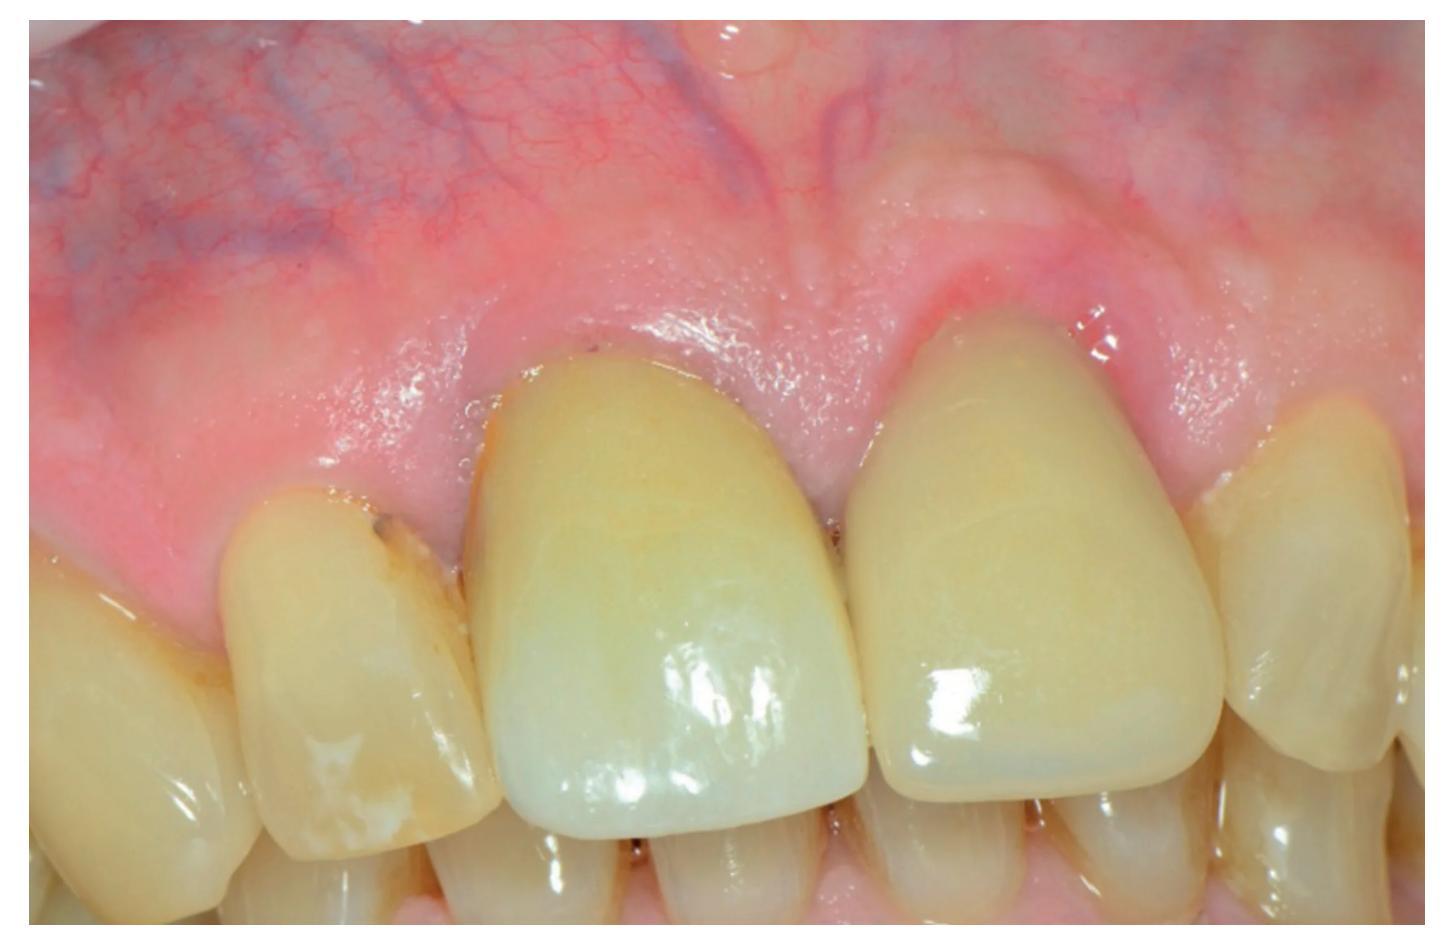
Fig 15. At 1-week post–crown insertion, the patient returned for delivery of the nightguard, and the gingival tissue at the implant restoration demonstrated good periodontal health with no marginal inflammation noted.

One week later the patient presented for an evaluation of the implant restoration and delivery of the nightguard. An absence of inflammation was noted at the gingival margins and the patient indicated he had been comfortable since restoration insertion (Figure 15). The mouthguard was inserted and the patient was given homecare instructions on the use of the appliance (Figure 16). The patient was scheduled for routine prophylaxis appointments. At the 1-year prophy recall appointment the gingival tissue around the implant restoration presented with a lack of inflammation and healthy soft tissue (Figure 17). A periapical radiograph was taken to check crestal bone levels (Figure 18). The grafted bone that had been placed crestally remained at proper levels demonstrating that healthy bone was being maintained to the implant's crestal portion.

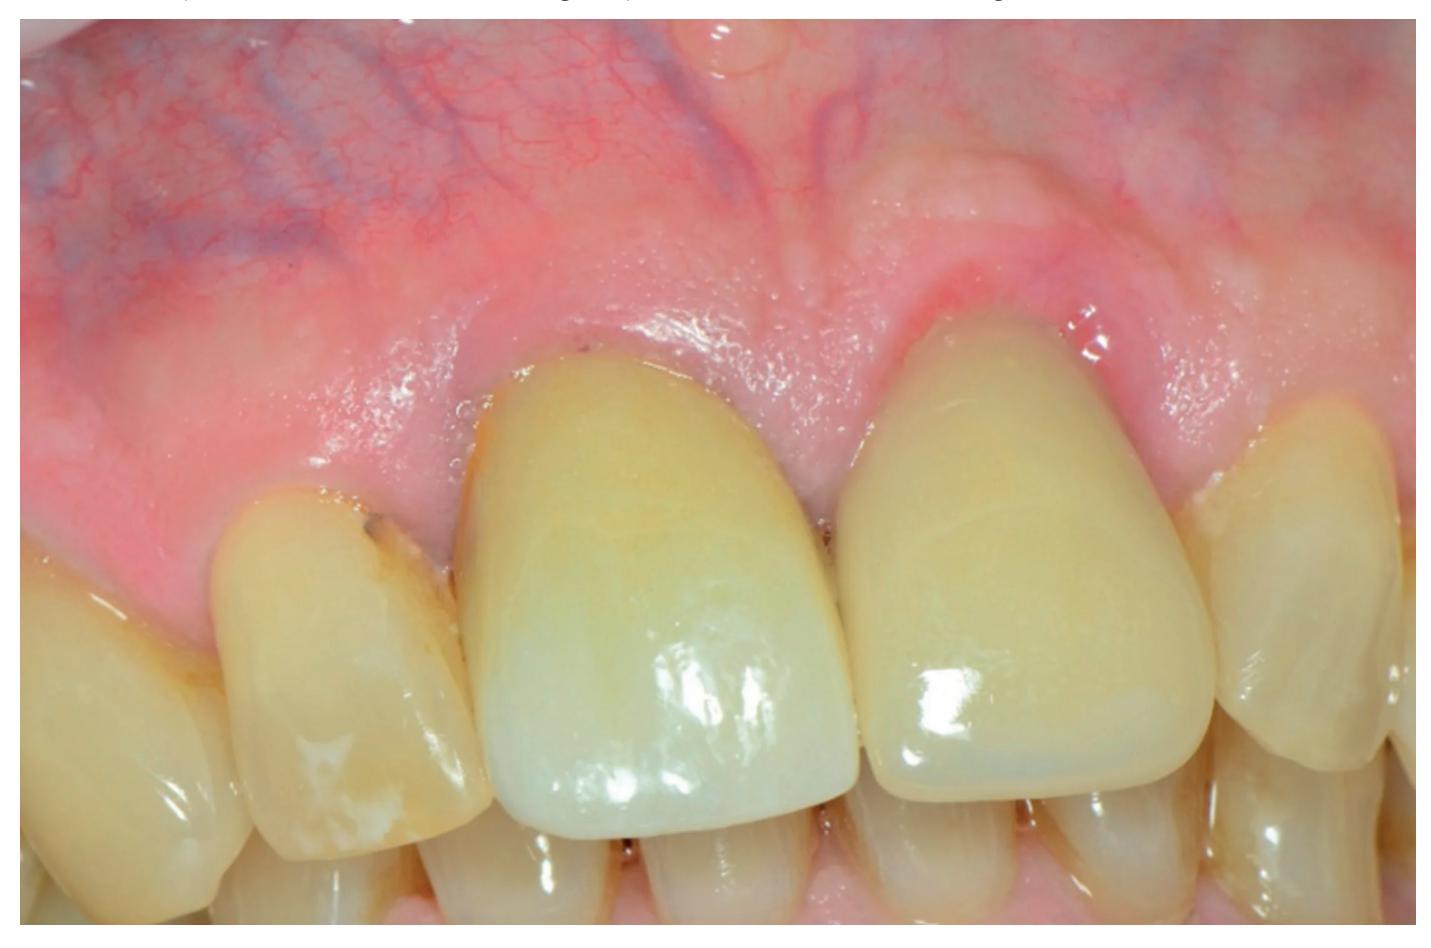
Fig 16. The maxillary nightguard was delivered.

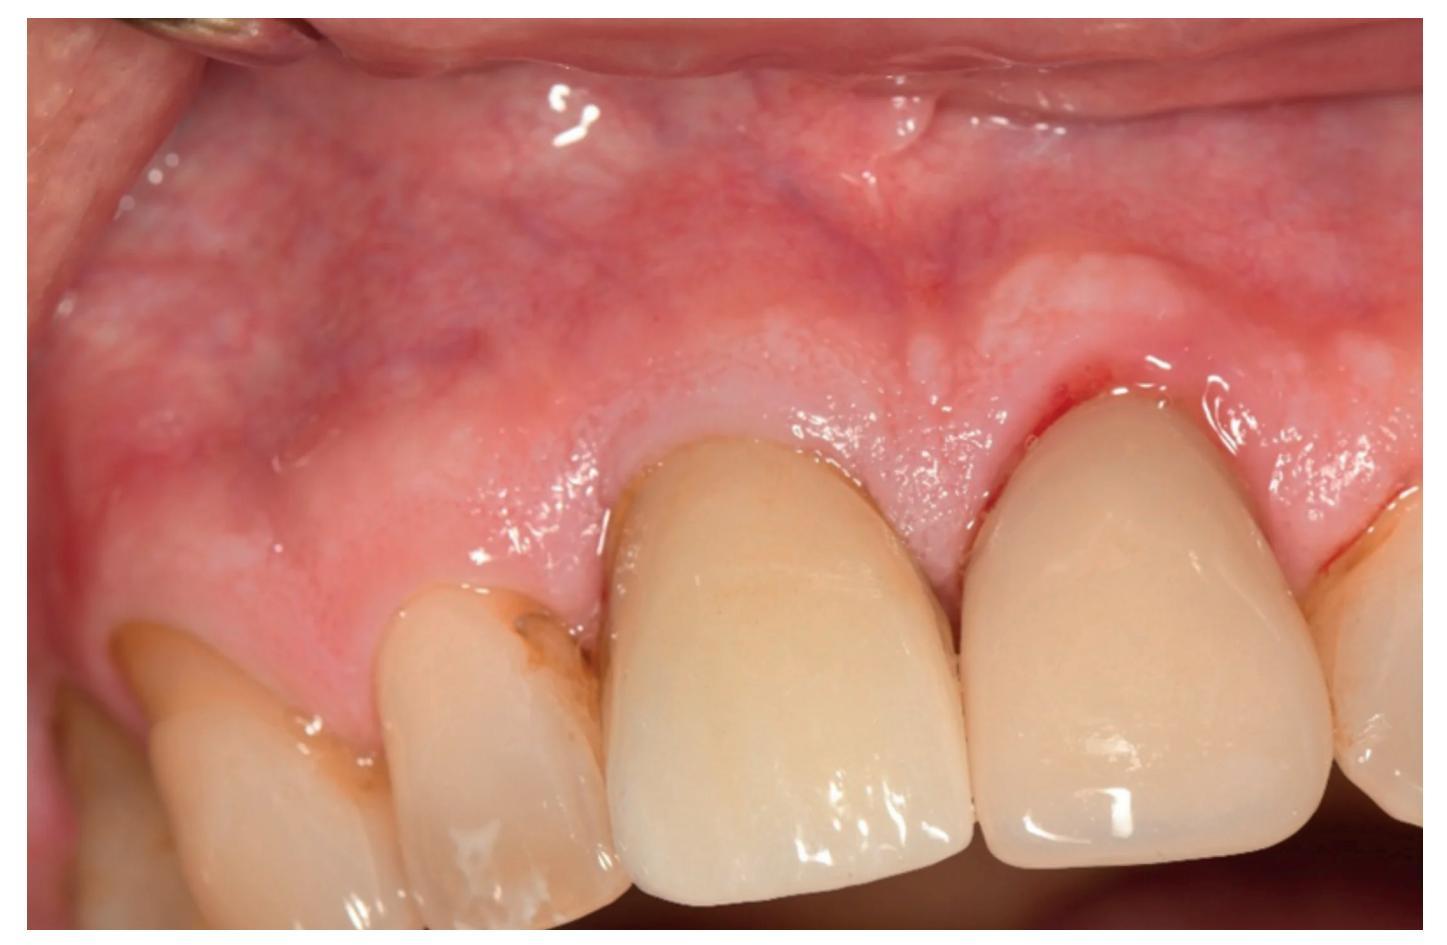
Fig 17. At 1-year post-restoration placement, the gingival tissue at the No. 8 implant remained absent of inflammation.

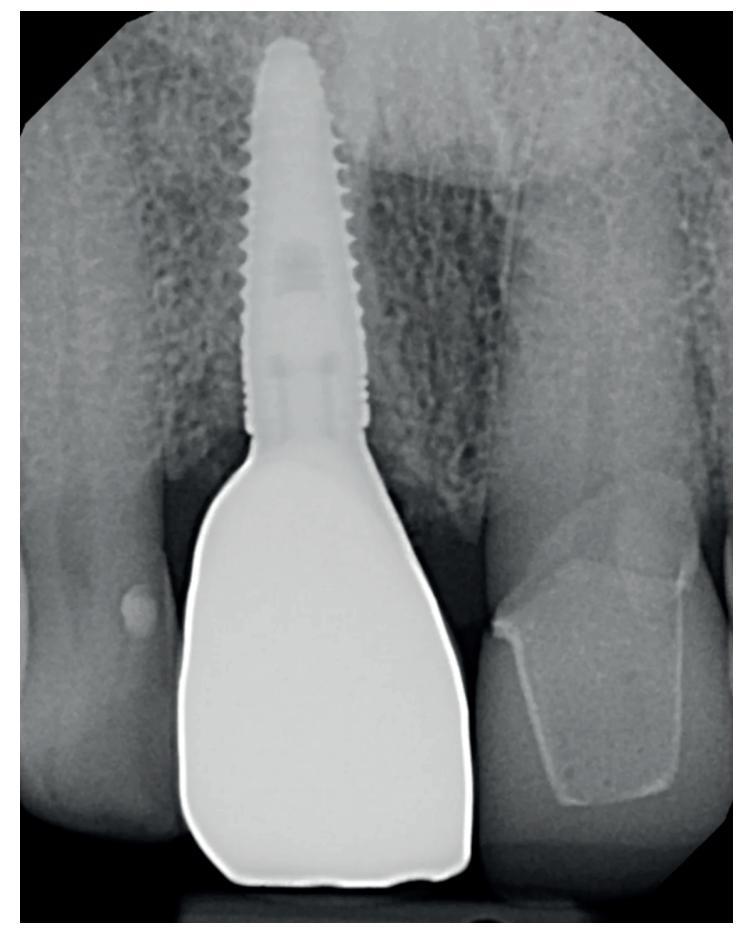
Fig 18. Periapical radiograph at 1-year post-restoration placement demonstrating maintenance of crestal bone.
